# Manhole Inspection Summary

Manhole # S55E\_\_012MH

Insp Date: **7/22/08 12:02 PM**

**Location** Address: **3512 mount pleasant av**

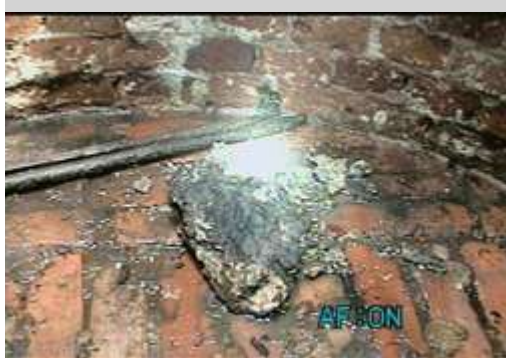
bench debris

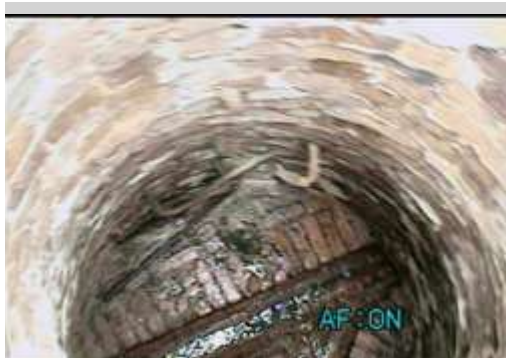
Defect 1

Condition: ☐ Sound ☒ **Cracked** ☐ Root Intrusion ☐ Loose Brick ☐ Deteriorated

chimney cracked, frame adj

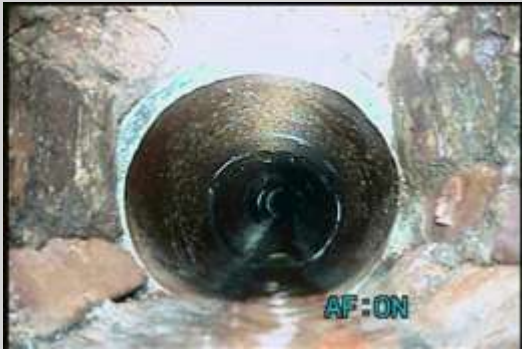
12 O'Clock Outflow

8 in. Circular Gravity Sewer  
Pipe Out @ 12 O'Clock

Deposits: ☒ None ☐ Mud ☐ Sludge ☐ Debris ☐ Grease

Infiltration: **None** Pipe Seal Cond: **Unknown**

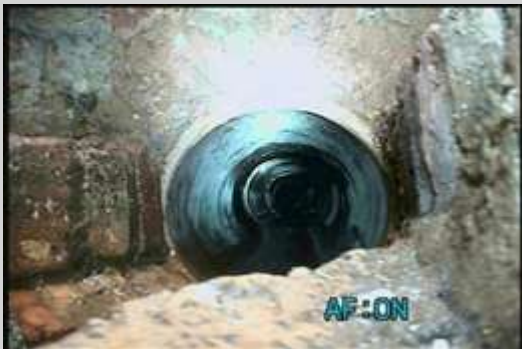
3 O'Clock Inflow

8 in. Circular Gravity Sewer  
Pipe In @ 3 O'Clock

Deposits: ☒ None ☐ Mud ☐ Sludge ☐ Debris ☐ Grease

Infiltration: **None** Pipe Seal Cond: **Unknown**

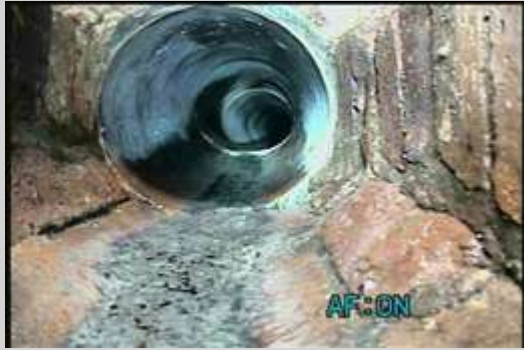
6 O'Clock Inflow

8 in. Circular Gravity Sewer  
Pipe In @ 6 O'Clock

Deposits: ☒ None ☐ Mud ☐ Sludge ☐ Debris ☐ Grease

Infiltration: **None** Pipe Seal Cond: **Unknown**
